NATIONAL CERTIFIED TESTING LABORATORIES

Report No.: NCTL-210-2277-1,2,3 (S)(C)(I)(F) DC Not. No. N/A

Test Conducted - DCBCCD PA 201-94, PA 202-94 & PA 203-94.

Design Pressure - +60.0 psf (Positive) -55.0 psf (Negative)

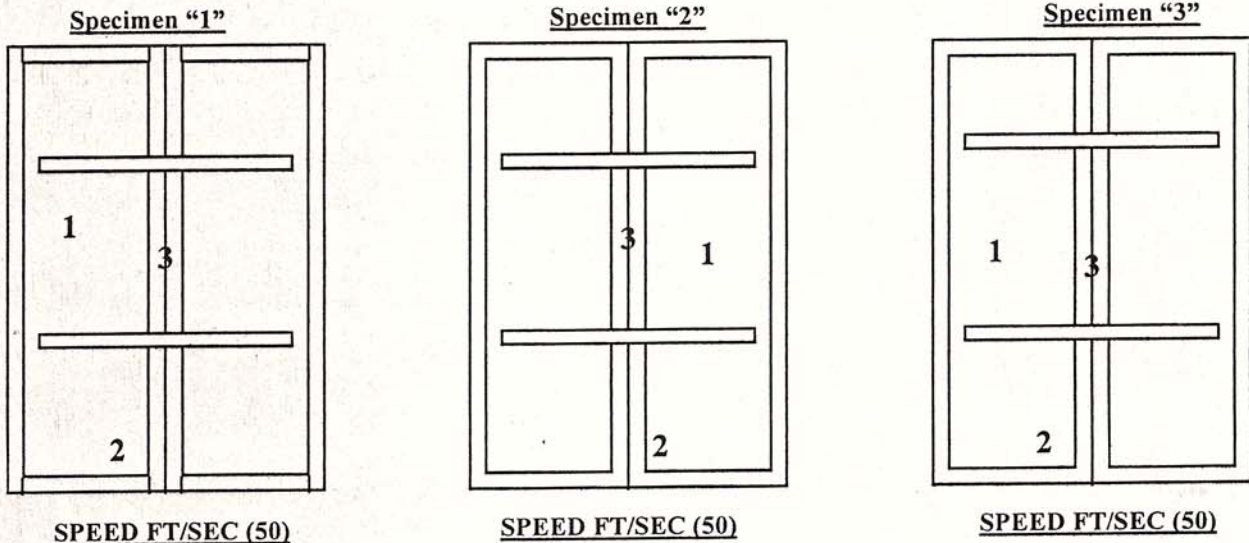
75 mph egress note: A 75 mph velocity (14.4 psf) positive and negative pressuer test was performed with only the lower security pipe engaged.

Type and weight of missile: # 2 Southern Yellow Pine 2 x 4 length approximately 89-5/16" & 9 lb.
